TECHNICAL BRIEFING ON PROOF CORING WORKS FOR MICROPILES

Presented by,
SS Liew
Foundtest Drilling Sdn Bhd.
<http://drilling.my>

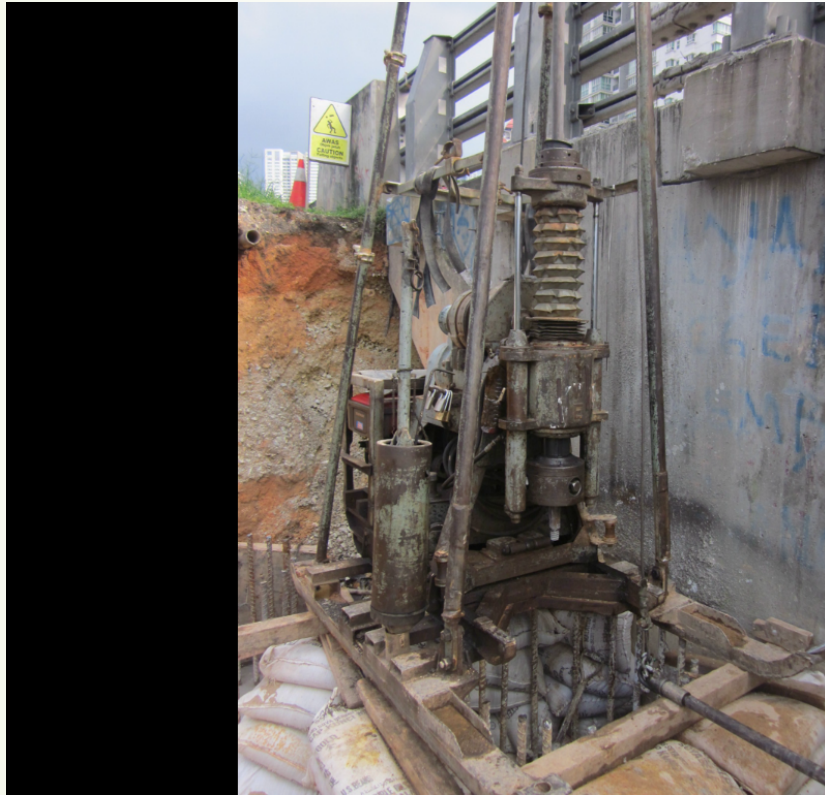
YWE D90R Boring
Machine

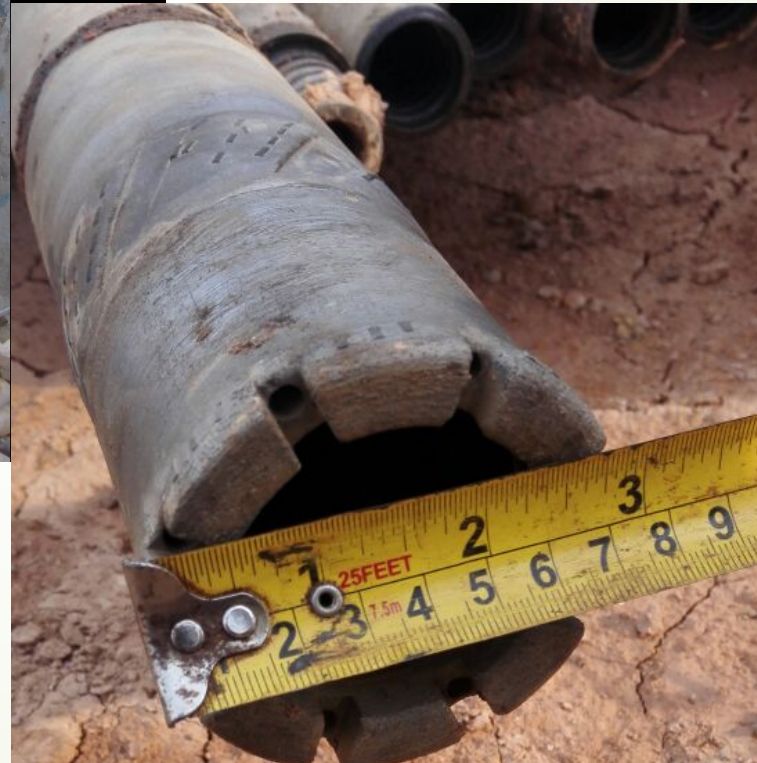
NMLC Core Barrel with
Diamond Core Bit

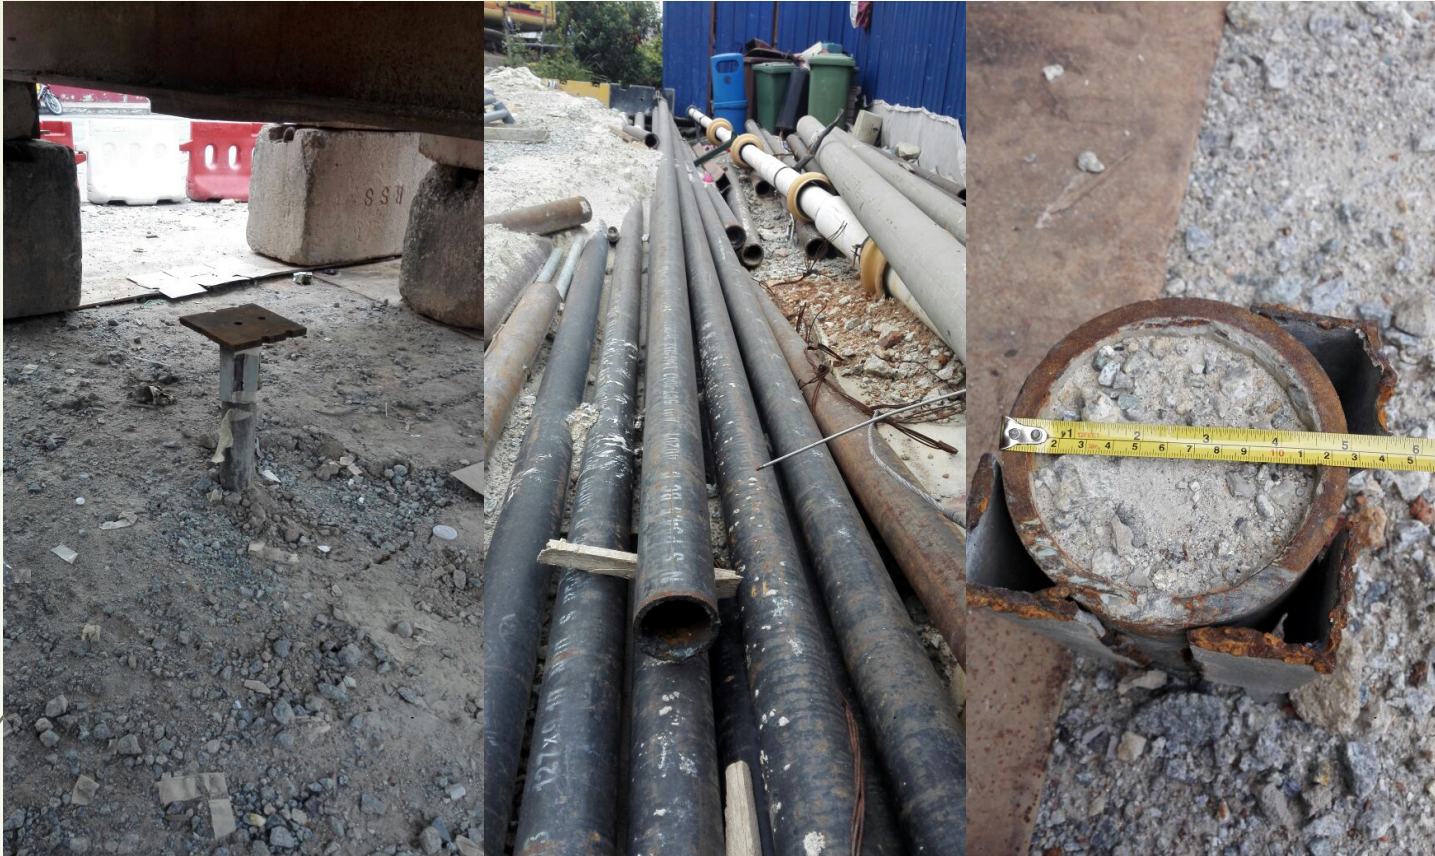
The Micropile is as shown in the photo above. The Subject to core is the Grout inside the API pipe. Vertically of the pile underneath the ground could not be assessed.

- The subject to core is the grout inside micropile API pipe of approximately 100mm inner diameter space using our core barrel of approximately 80mm outer diameter (Only left 10mm allowance space). The risk of damaging the coring accessories is high due to the unprecedented alignment of the API pipe underneath the ground up to the depth of 30m. A very minor inclination of the pipe could lead to collision of the core bit and API pipe of the pile. Therefore, client needs to agree with the clause to bear the cost of the drilling accessories if damaged (Specified in the quotation). If the coring path collides with the API pipe, further coring deeper is might be no longer feasible, and we do not responsible for the damage of the API pipe during the coring works.

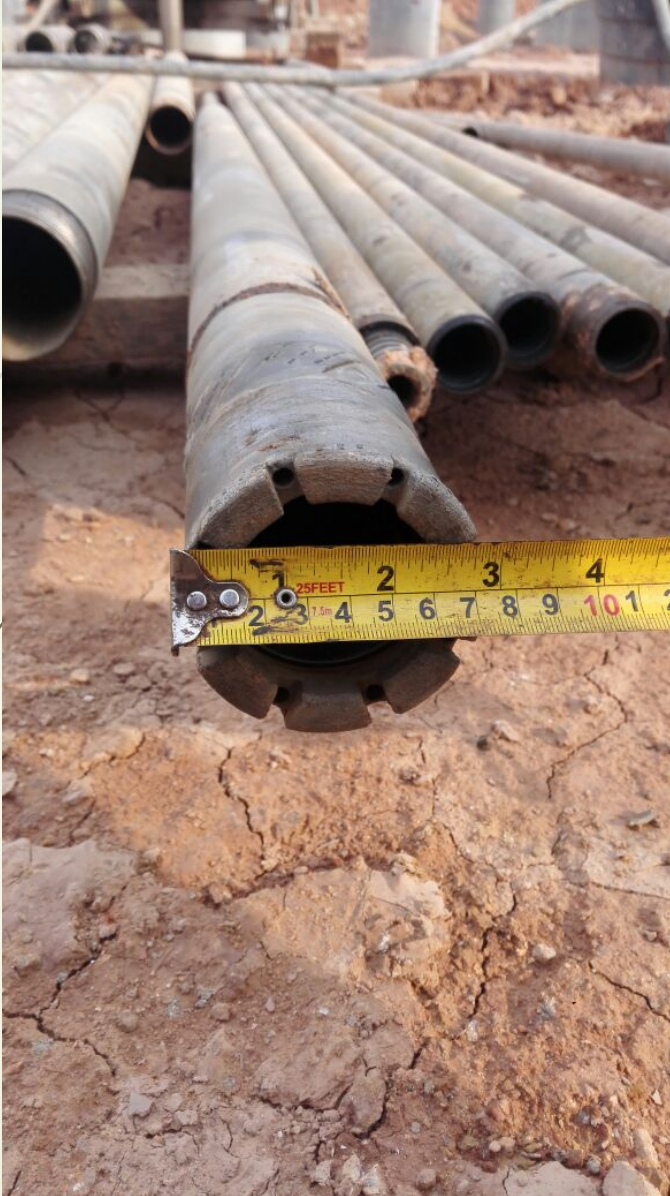
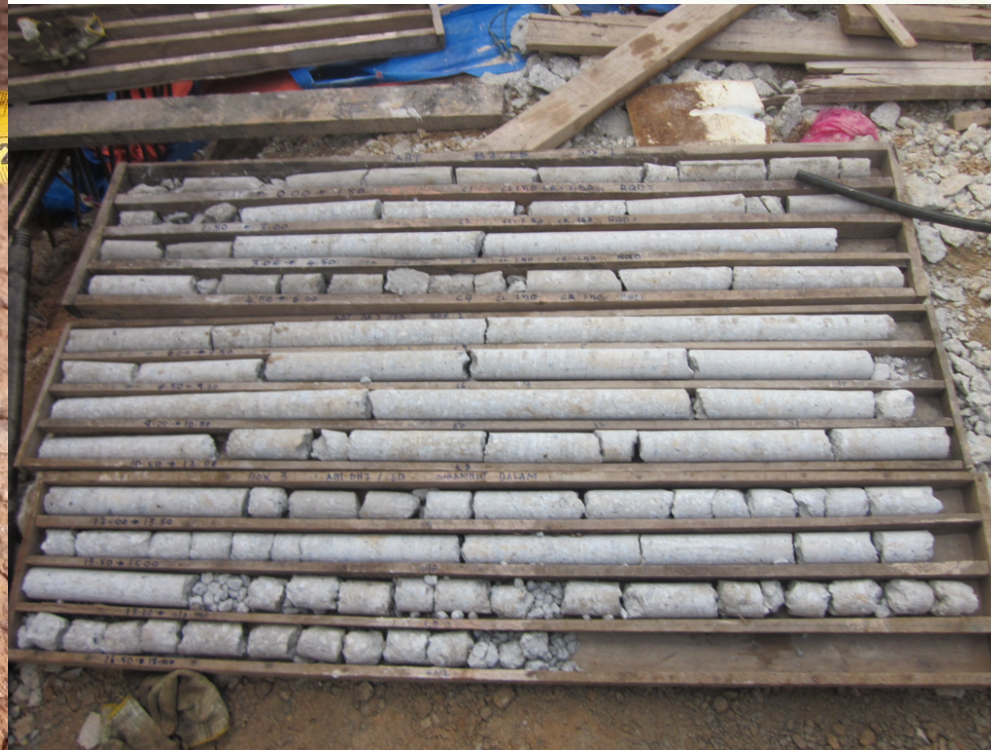
Our NMLC Core Barrel with Diamond Core Bit is as shown in the left picture and the expected core samples is as shown below with 54mm diameter.

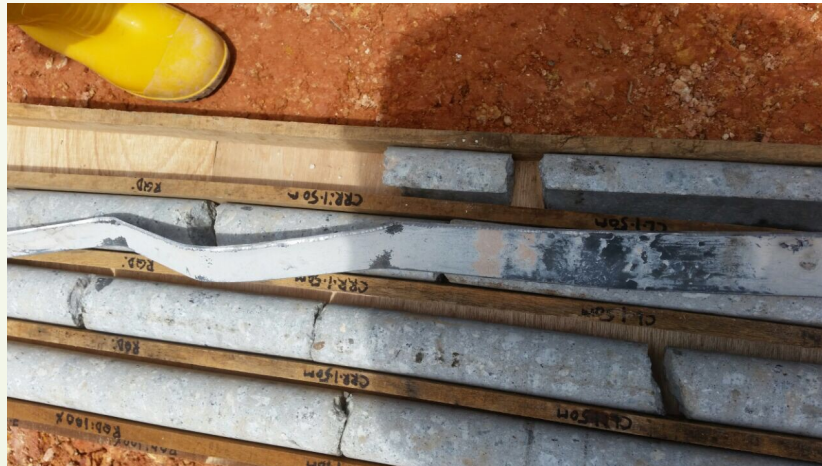
Photos shows previous Proof Coring Works done on bore pile whereby the core cut through the sonic logging tube installed inside the pile. The Core Barrel & Bit was damaged.

- As mentioned earlier, the API pipe has a really small gap for our core bit to access. Therefore, it poses a high risk of collision between our core bit and the API pipe's internal wall.
- When this happens, there is a possibility that:
 1. The bit would cut through the API pipe, damaging both the bit and the API pipe.
 2. The bit would jammed inside the API pipe, unable to penetrate and damaged. Further coring downward also not longer possible.
 3. The bit would lead by the API pipe to the bottom, without damaging the API pipe and the core barrel.
- We need to highlight all the possibilities so that each party would be clear on the cost and technical issue that might arise before we commence on the work.
